Restoration of endodontic teeth: An engineering perspective

Author_ Dr Gregori M. Kurtzman, USA

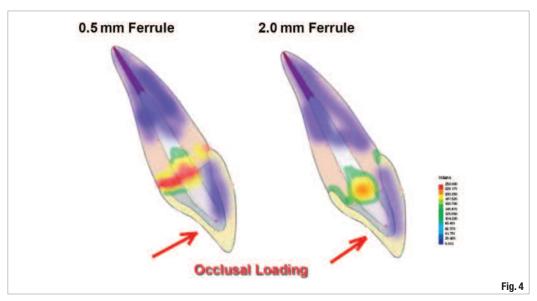
Fig. 4_Difference of intensity of strain and location related to ferrule height during occlusal loading (Libman).

Additionally, if we look at strain studies by Libman and others comparing ferrule of different heights, we observe that in a ferrule of 0.5 mm there is greater strain at the margin under tension and concentrates at mid tooth where the core or post is situated. Teeth with 2.0 mm of ferrule demonstrated significantly less strain loading at the margins or centre of the cervical aspect of the tooth. The lower the strain at the cervical midpoint, the less chance of overload and failure restoratively (Fig. 4).

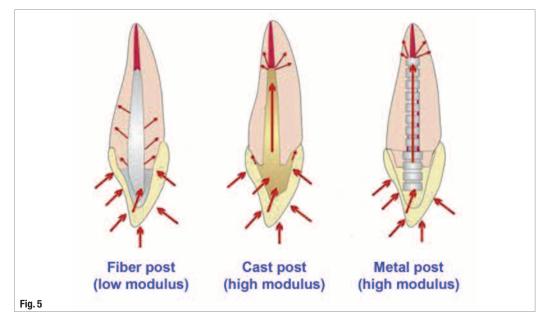
Fig. 5_Comparison of load distribution of fiber posts compared to a cast post and prefabricated metal post.

Teeth function differently, depending on the material that the post is fabricated from, with loads distributed within the root relative to the modulus of elasticity of the post compared to the dentin of the root (Fig. 5).

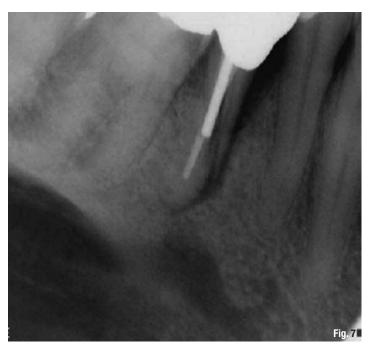
Fig. 7_Vertical root fracture of a tooth restored with a metal post.

As metal posts are stiffer (higher modulus of elasticity) than the dentin of the root, with metal posts stress concentrated at the posts apical leading to vertical root fracture and catastrophic loss of the tooth. Ansari reported, "The risk of failure was greater with metal-cast posts (nine out of 98 metal posts failed) than with carbon fiber posts (using which, none out of 97 failed) risk ratio." ¹⁵ But with fiber posts having a flexibility equal or greater then the root (lower modulus of elasticity) stress concentrated at the cervical region leading to horizontal fracture of the post and core and typically the tooth can be salvaged.
