Restoration of endodontic  
teeth: An engineering  
perspective

# Restoration of endodontic teeth: An engineering perspective

**Author**\_Gregori M. Kurtzman, DDS, MAGD, FAAIP, FPFA, FACD, FADI, DICOI, DADIA

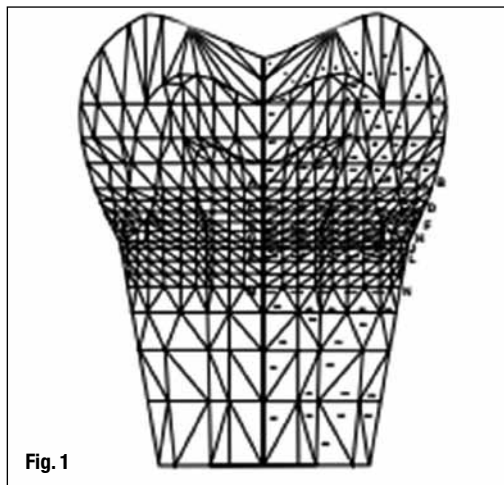
**Fig. 1**

**Fig. 1**\_Strain analysis of a posterior tooth demonstrating concentration of strain on loading at the cervical. (Image/Provided by Dr. Gene McCoy)

It is important to attempt to retain as much tooth structure as possible, and this aids in achieving ferrule as well as maintaining cervical strength of the tooth where loading concentrates. Under masticatory loading, strain concentrates at the cervical portion of teeth; thus it is important to avoid over-preparation of this portion of the tooth during endodontic treatment and preserve this area during restoration of the tooth (Fig. 1).

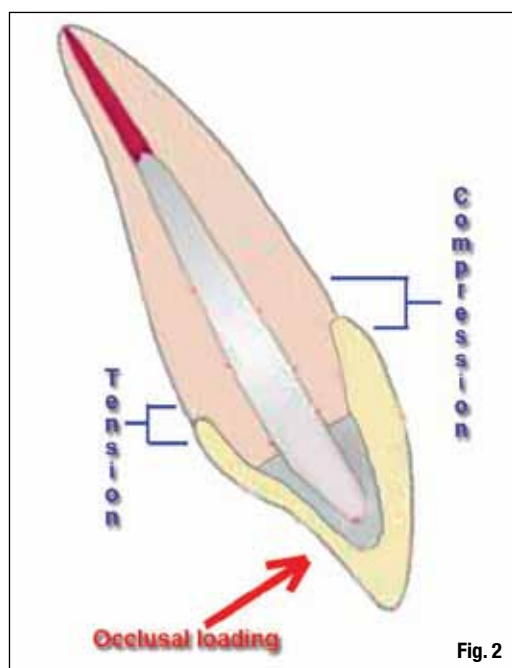
Fig. 2

**Fig. 2\_** As a maxillary anterior tooth is loaded during mastication, tension and compression occur at the crown's margins. (Images/Provided by Dr. Gregori M. Kurtzman)

Libman further demonstrated when loading at an off-axis direction, which occurs in the maxillary anterior, at the restoration's margin, the side where the load is originating is under tension, whereas the opposing side is under compression (Fig. 2). This repetitive loading and micro strain due to tension at the lingual margin leads to the margin opening, which may lead to recurrent decay and/or failure of the endodontic seal or restoration (Fig. 3).

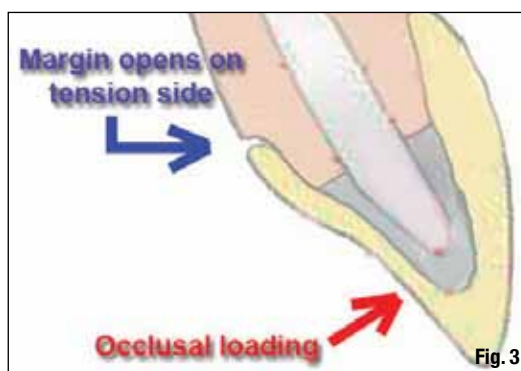
Fig. 3

**Fig. 3\_** Opening of the margin on the tension side may lead in time to recurrent decay or restoration and endodontic failure.

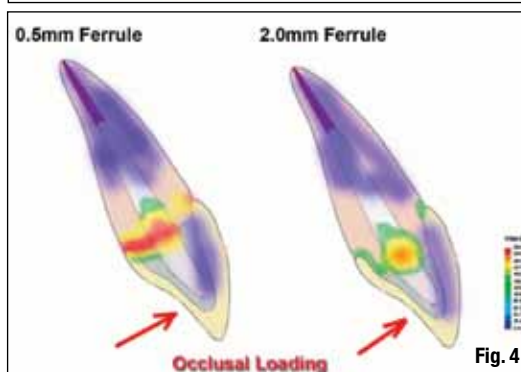
Fig. 4

**Fig. 4\_** Difference of intensity of strain and location related to ferrule height during occlusal loading (Libman).

Additionally, if we look at strain studies by Libman and others comparing ferrule of different heights, we observe that in a ferrule of 0.5 mm there is greater strain at the margin under tension and concentrates at mid tooth where the core or post is situated. Teeth with 2.0 mm of ferrule demonstrated significantly less strain loading at the margins or center of the cervical aspect of the tooth. The lower the strain at the cervical

midpoint, the less chance of overload and failure restoratively (Fig. 4).

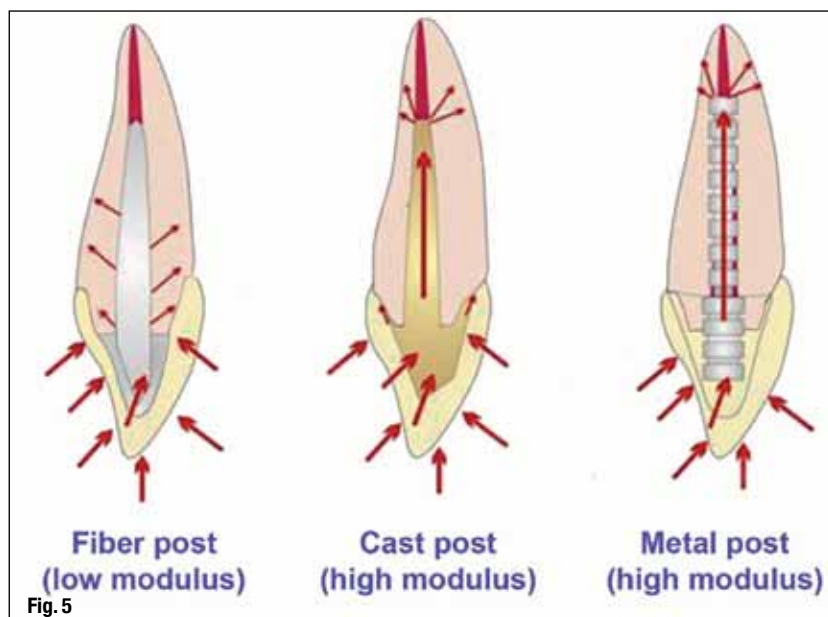
**Fig. 5** Comparison of load distribution of fiber post, cast metal post and prefabricated metal post.

distributed within the root relative to the modulus of elasticity of the post compared to the dentin of the root (Fig. 5).

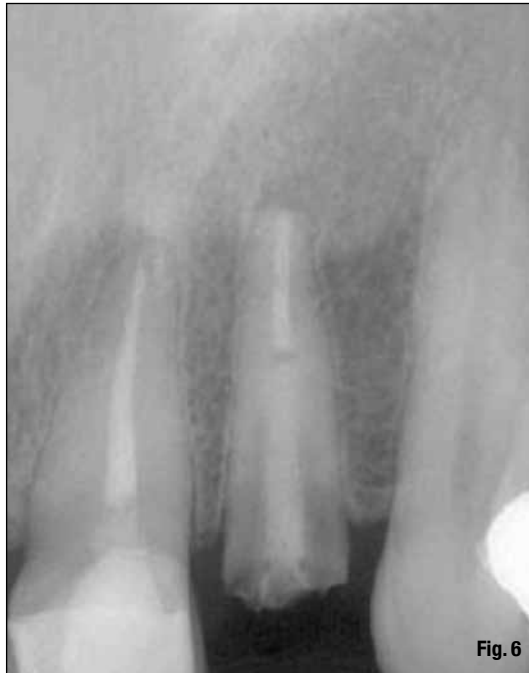
Fig. 6

**Fig. 6** Tooth restored with a fiber post demonstrating coronal horizontal fracture supracrestally, typically seen with teeth restored with fiber posts when overloaded.

Bitter reported, "Compared to metal posts, FRC posts revealed reduced fracture resistance *in vitro*, along with a usually restorable failure mode"<sup>13</sup> (Fig. 6). Whereas, with metal posts either prefabricated or cast, failure was at a higher value for cast post and core: 91 percent of the specimens had fractured roots (none of the specimens with a fiber post demonstrated root fracture); and the post and core usually fractured at the tooth composite core interface.<sup>14</sup>

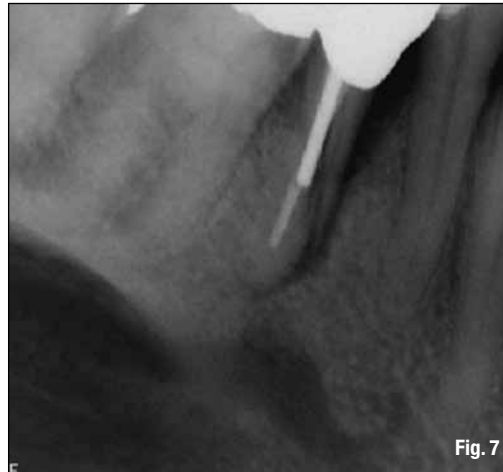
Fig. 7

**Fig. 7** Vertical root fracture of a tooth restored with a metal post.

As stress concentrates at the apical tip of the metal post due to its higher modulus of elasticity than the surrounding root, vertical root fracture is a frequent occurrence (Fig. 7). This may result also from breakdown of the cement luting the post to the root, allowing slippage microscopically of the post in the tooth under load, leading to torque at the cervical area and the resulting vertical root fracture.

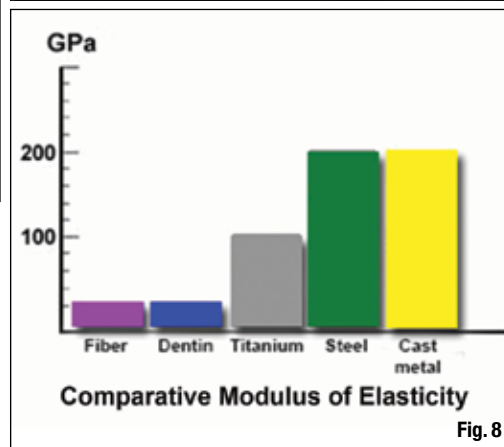
Fig. 8

**Fig. 8** Comparative modulus of elasticity of different post materials.

Cast posts fabricated from noble or base metals have higher modulus than high noble alloys and approach stainless-steel prefabricated posts in their relative stiffness. Fiber posts have an elastic modulus that more closely approaches that of dentin (Fig. 8). The flexural strength of fiber and metal posts was respectively four and seven times higher than root dentin, and there is still debate on whether a post
