Dental Tribune

Published in India www.dental-tribune.com Vol. 1 No. 1

Endodontic retreatment

Achieving success the second time around

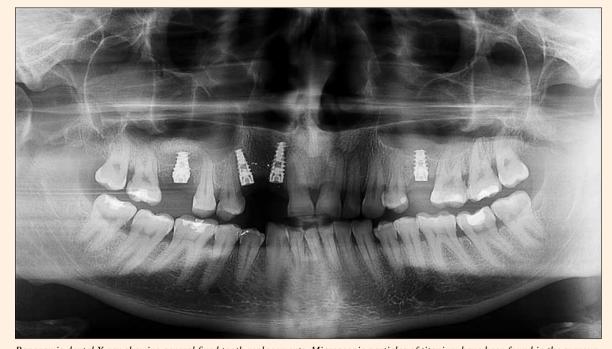
Panoramic dental X-ray showing several fixed tooth replacements. Microscopic particles of titanium have been found in the surrounding tissue of medical implants. (DTI/Photo Natasha Spiridonova, Ukraine)

"The results showed, for the first time, a scattered and heterogeneous distribution of titanium in inflamed tissue taken from around failing skinpenetrating titanium implants," the authors reported. "Wear processes and implant debris were unlikely to be major contributors to the problem. In the absence of obvious macroscopic wear or loading processes, we propose that the titanium in the tissue results from micro-motion and localised corrosion in surface crevices."

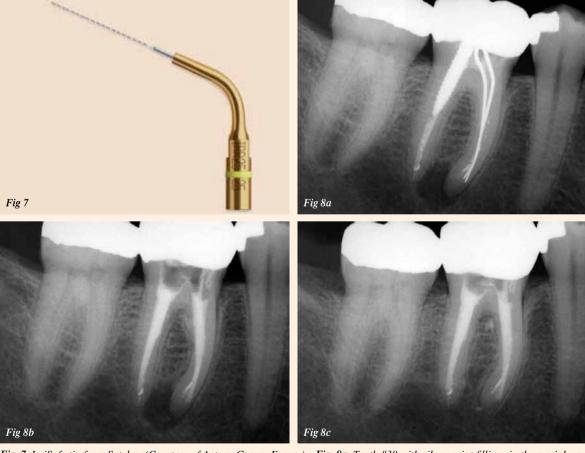
Fig. 7: IrriSafe tip from Satelec. (Courtesy of Acteon Group, France)—Fig. 8a: Tooth #30 with silver-point fillings in the mesial root and a post in the distal root. The mesial root-canal preparations are transported towards the mesial. There is a radiolucent periapical lesion.—Fig. 8b: Post-op radiograph.—Fig. 8c: Fifteen-month follow-up. (Courtesy of Dr Brett E Gilbert)

Passive ultrasonic irrigation allows clinicians to place an irrigant solution into the pulp chamber and activate it as it is carried down to the apical end of the root canal. The IrriSafe tip from Satelec (Acteon; Fig 7) is a noncutting ultrasonic file that is placed into each canal and is moved up and down in the canal for three cycles of 20 seconds. Passive ultrasonic irrigation has been shown to irrigate lateral canals better at 4.5 and 2 mm from the working length of canals as compared with needle irrigation alone.²⁵ It has been demonstrated that passive ultrasonic irrigation can remove dentine debris in a canal up to 3 mm in front of where the tip extends apically in straight or curved canals.²⁶ This evidence shows that an effective flow of irrigation can assist in the cleansing of teeth in which canal alteration occurred during the initial root-canal treatment.

The following silver-point case (Figs 8a-c), with a large distal post and apical transportation in the mesial root, demonstrates the successful healing of post-treatment disease when proper disinfection has been accomplished. This case illustrates the reason that retreatment is the primary treatment option for post-treatment disease.

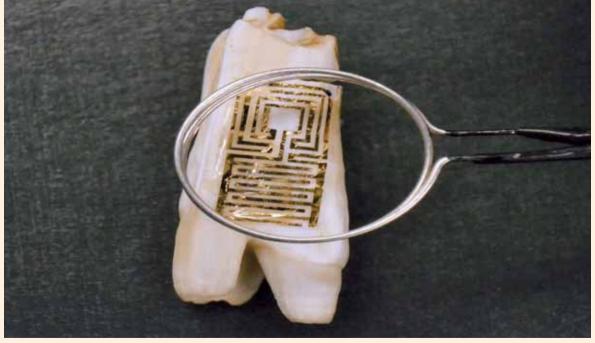
The sensor consists of a graphene layer printed on to a bioresorbable silk substrate. (DTI/Photo Princeton University, USA)

The signals are received from a gold antenna on a tattoo that is attached to an array of graphene-very small particles of carbon-that triggers a signal when in contact with bacteria through attached proteins

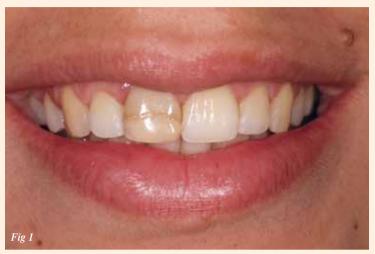
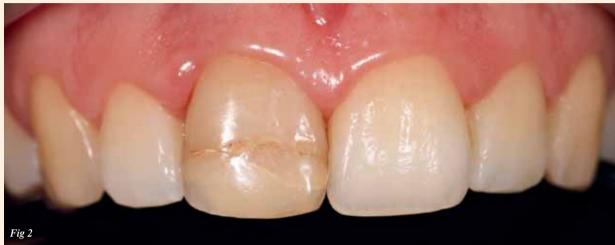
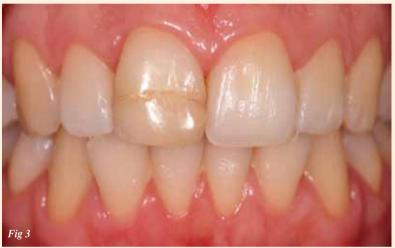
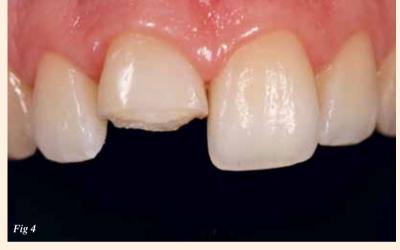
Fig. 1: Severely discoloured tooth#11.— Fig. 2: The shape of tooth #11 appeared to be harmonious with tooth #21. The substance loss amounted to somewhat less than half of the tooth.—Fig. 3: After the bleaching procedure, the shade of tooth #11 was optimal.—Fig. 4: Prepared tooth #11 with vestibular chamfer and straight, right-angle palatal margin.

A 24-year-old female patient presented at our practice with a request regarding aesthetics. She disliked the appearance of tooth #11, which showed severe discolouration after endodontic treatment. A clinical examination revealed that the root had been extirpated after an accident and that a fractured piece had been reattached with a composite material (Figs 1 & 2). Upon radiological examination, it was found that the root-canal treatment had been performed correctly. However, a post had not been used.

The existing restoration was removed with the help of both rotary and ultrasonic instruments and with care to prevent any damage to the adjacent teeth. During the preparation of the tooth, the mechanical properties of the material used and the aesthetic integration needed to be taken into account. In the case of IPS Empress Direct, the ideal preparation design involved a vestibular chamfer and a straight, right-angle proximal and palatal margin (Fig. 4).
