Restoration of endodontic teeth: An engineering perspective

Author_ Dr Gregori M. Kurtzman, USA

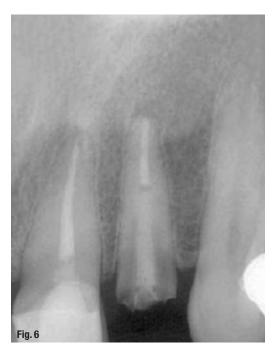
Fig. 6_Tooth restored with a fiber post demonstrating coronal horizontal fracture supracrestally typically seen with teeth restored with fiber posts when overloaded.

When a tooth restored with a fiber post does fail due to overload, the mode of failure is coronal, protecting remaining root and tooth structure.12 This mode of failure with fiber-post-restored teeth typically allows the tooth to be restored, as vertical root fracture is a rare occurrence. Bitter reported, "Compared to metal posts, FRC posts revealed reduced fracture resistance in vitro, along with a usually restorable failure mode"13 (Fig. 6). Whereas, with metal posts either prefabricated or cast, failure was at a higher value for cast post and core 91 per cent of the specimens had fractured roots, none of the specimens with a fiber post demonstrated root fracture; the post and core usually fractured at the tooth composite core interface.14 As stress concentrates at the apical tip of the metal post due to its higher modulus of elasticity than the surrounding root, vertical root fracture is a frequent occurrence (Fig. 7). This may result also from breakdown of the cement luting the post to the root, allowing slippage microscopically of the post in the tooth under load, leading to torque at the cervical area and the resulting vertical root fracture.
