# implants

# Immediate placement and loading of ceramic implants in the aesthetic region: One-year follow-up—two case reports

Drs Alexandre Marques Paes da Silva, Dennis de Carvalho Ferreira, Thamires Alves Silva, Mayla Kezy Silva Teixeira, Daniel de Moraes Telles & Eduardo José Veras Lourenço, Brazil

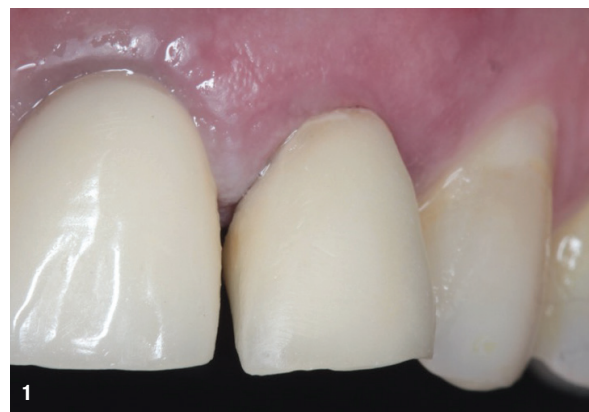
Fig. 1: Situation on initial clinical examination.

A 66-year-old female patient who was a smoker presented with the main complaint of a broken anterior tooth. On clinical examination, it was noted that the maxillary left lateral incisor had a metal-ceramic crown with a partially displaced cast metallic core (Fig. 1). The CBCT examination showed the presence of a vertical root fracture due to recurrent caries (Fig. 2). Given the clinical and radiographic situation, the proposed treatment was the extraction of the tooth in question, followed by immediate placement of a ceramic implant and immediate restoration with a crown.
